NIST NCSTAR 2: Vol. I

Report of the Technical Investigation of The Station Nightclub Fire

June 2005

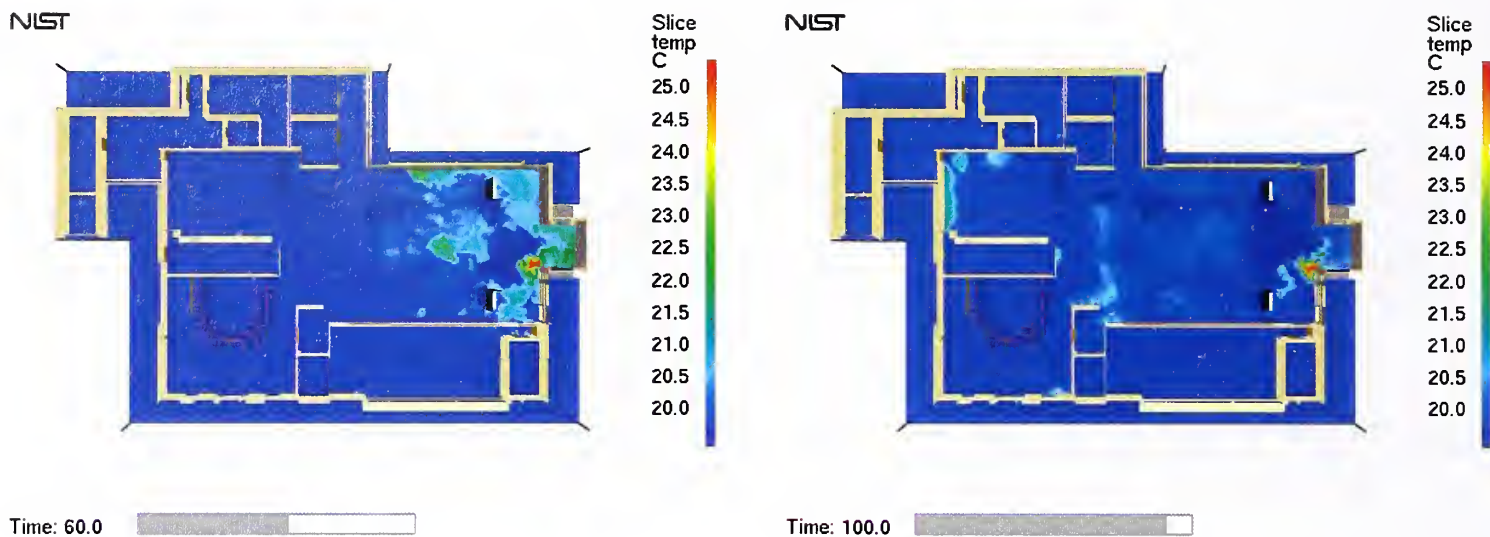
Isothermal plots are shown in Figures 5-66a and 5-66b to assess the tenability conditions based on temperatures that were predicted during the simulation of the fire. The figures show horizontal isothermal images 1.5 m (5 ft) above the floor from the time of ignition ($t = 0$) to 100 seconds at 10 second intervals, and an image at 150 seconds. Due to the rapid activation of the sprinklers (three sprinklers were operating by 30 seconds after ignition), the temperatures at the 1.5 m (5 ft) level remain well below the temperature tenability threshold of 120 °C (248 °F) [6].

The comparison between the temperatures 1.5 m (5 ft) above the floor in the non-sprinklered simulation (Figure 5-55) and in the sprinklered configuration (Figs. 5-66a and 5-66b) show dramatically different thermal conditions. (Note the large difference in color scales.) During the non-sprinklered simulation temperatures exceeded 1000 °C (1830 °F) in the platform and dance floor areas, and in the main bar room they exceeded 500 °C (930 °F) within 100 seconds. In the sprinklered simulation, the temperature exceeds 25 °C at head height only near the platform; following sprinkler activation around 20 seconds, the thermal environment remains close to ambient up until the time the fire is fully extinguished at 120 seconds.

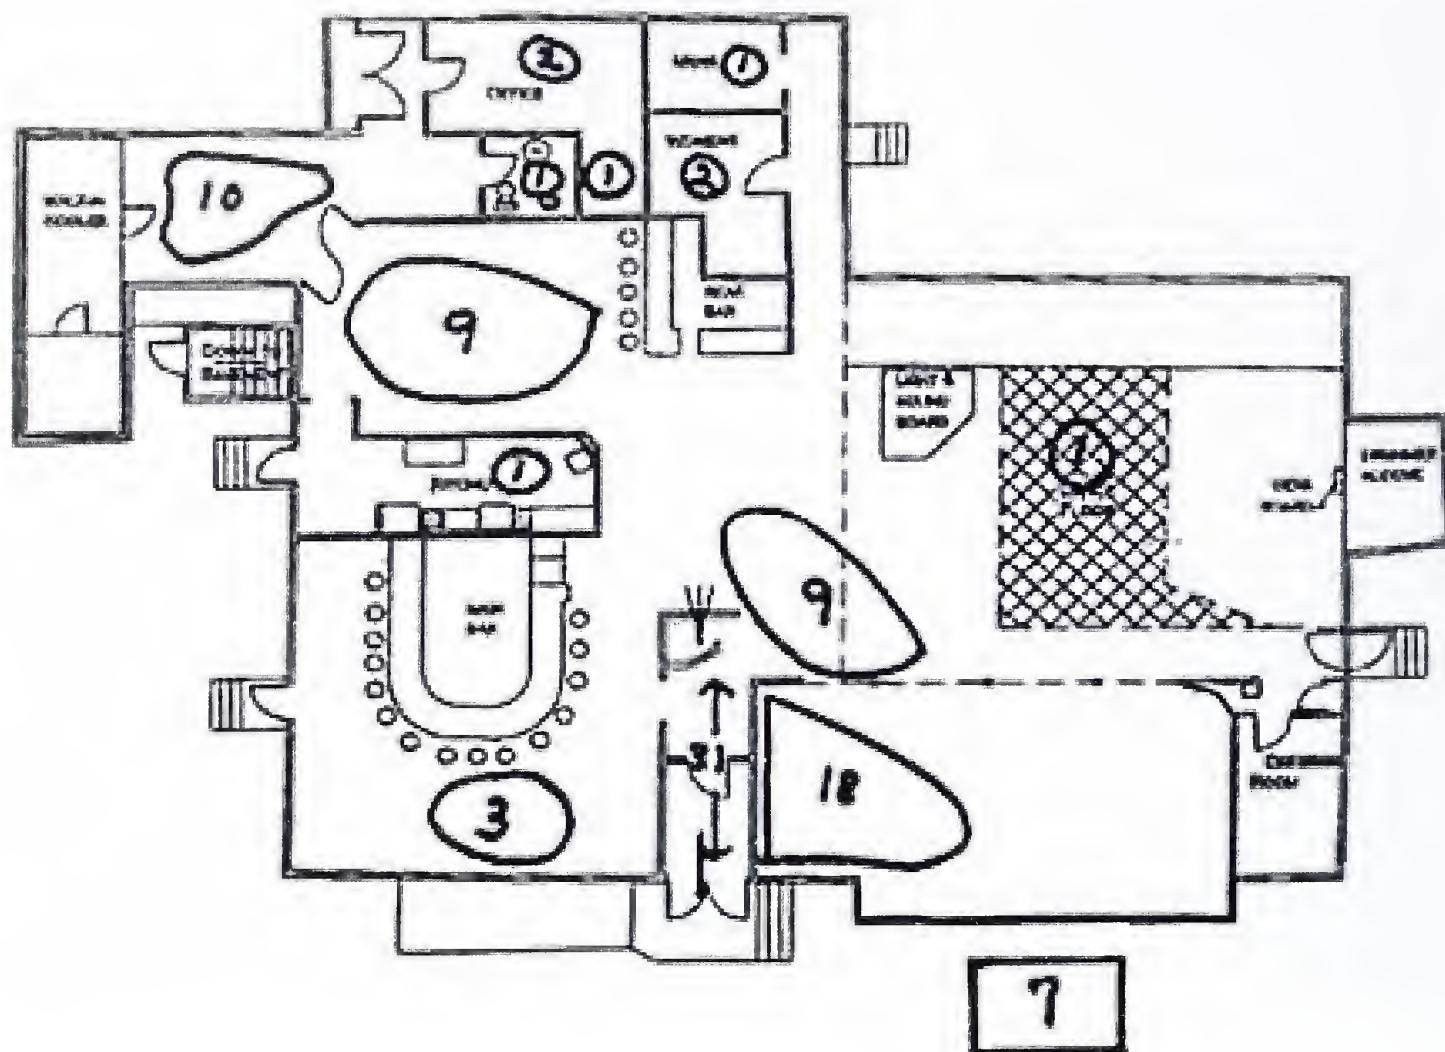
Figure 6-14. Location of Recovered People Who Died at Scene [36]

The Rhode Island Attorney General's office released a diagram of the approximate location where the rescuers recovered the 96 people who died at the scene of the fire [36] (See Figure 6-14.); 58 of these were located in the main entryway, at the entrance to the main entryway, or trapped in the sunroom. Taken together with the 91 who escaped through the front door, this translates to 56 % of the occupants apparently selecting the main entrance as a route to safety. Including the people who chose the windows only after the main exit became impassable, one could argue that as many as 2/3 of the occupants attempted (at least initially) to leave through the main entrance in the front of the building. Only about 40% of those who successfully evacuated escaped through the main entrance.

The small number of victims shown in Figure 6-14 who were found in the main bar room suggests that the main bar room exit door and windows provided open routes to escape for a time period about as long as it took to reach untenable conditions in that area of the building. By contrast, the high number of victims found in the sunroom relatively close to the windows suggests that the environment there became untenable quickly, eliminating the option of a secondary route through the sunroom windows once the platform door and main entrance became unusable. Both of these conclusions are consistent with the environmental conditions predicted in the FDS simulations discussed in Chapter 5.

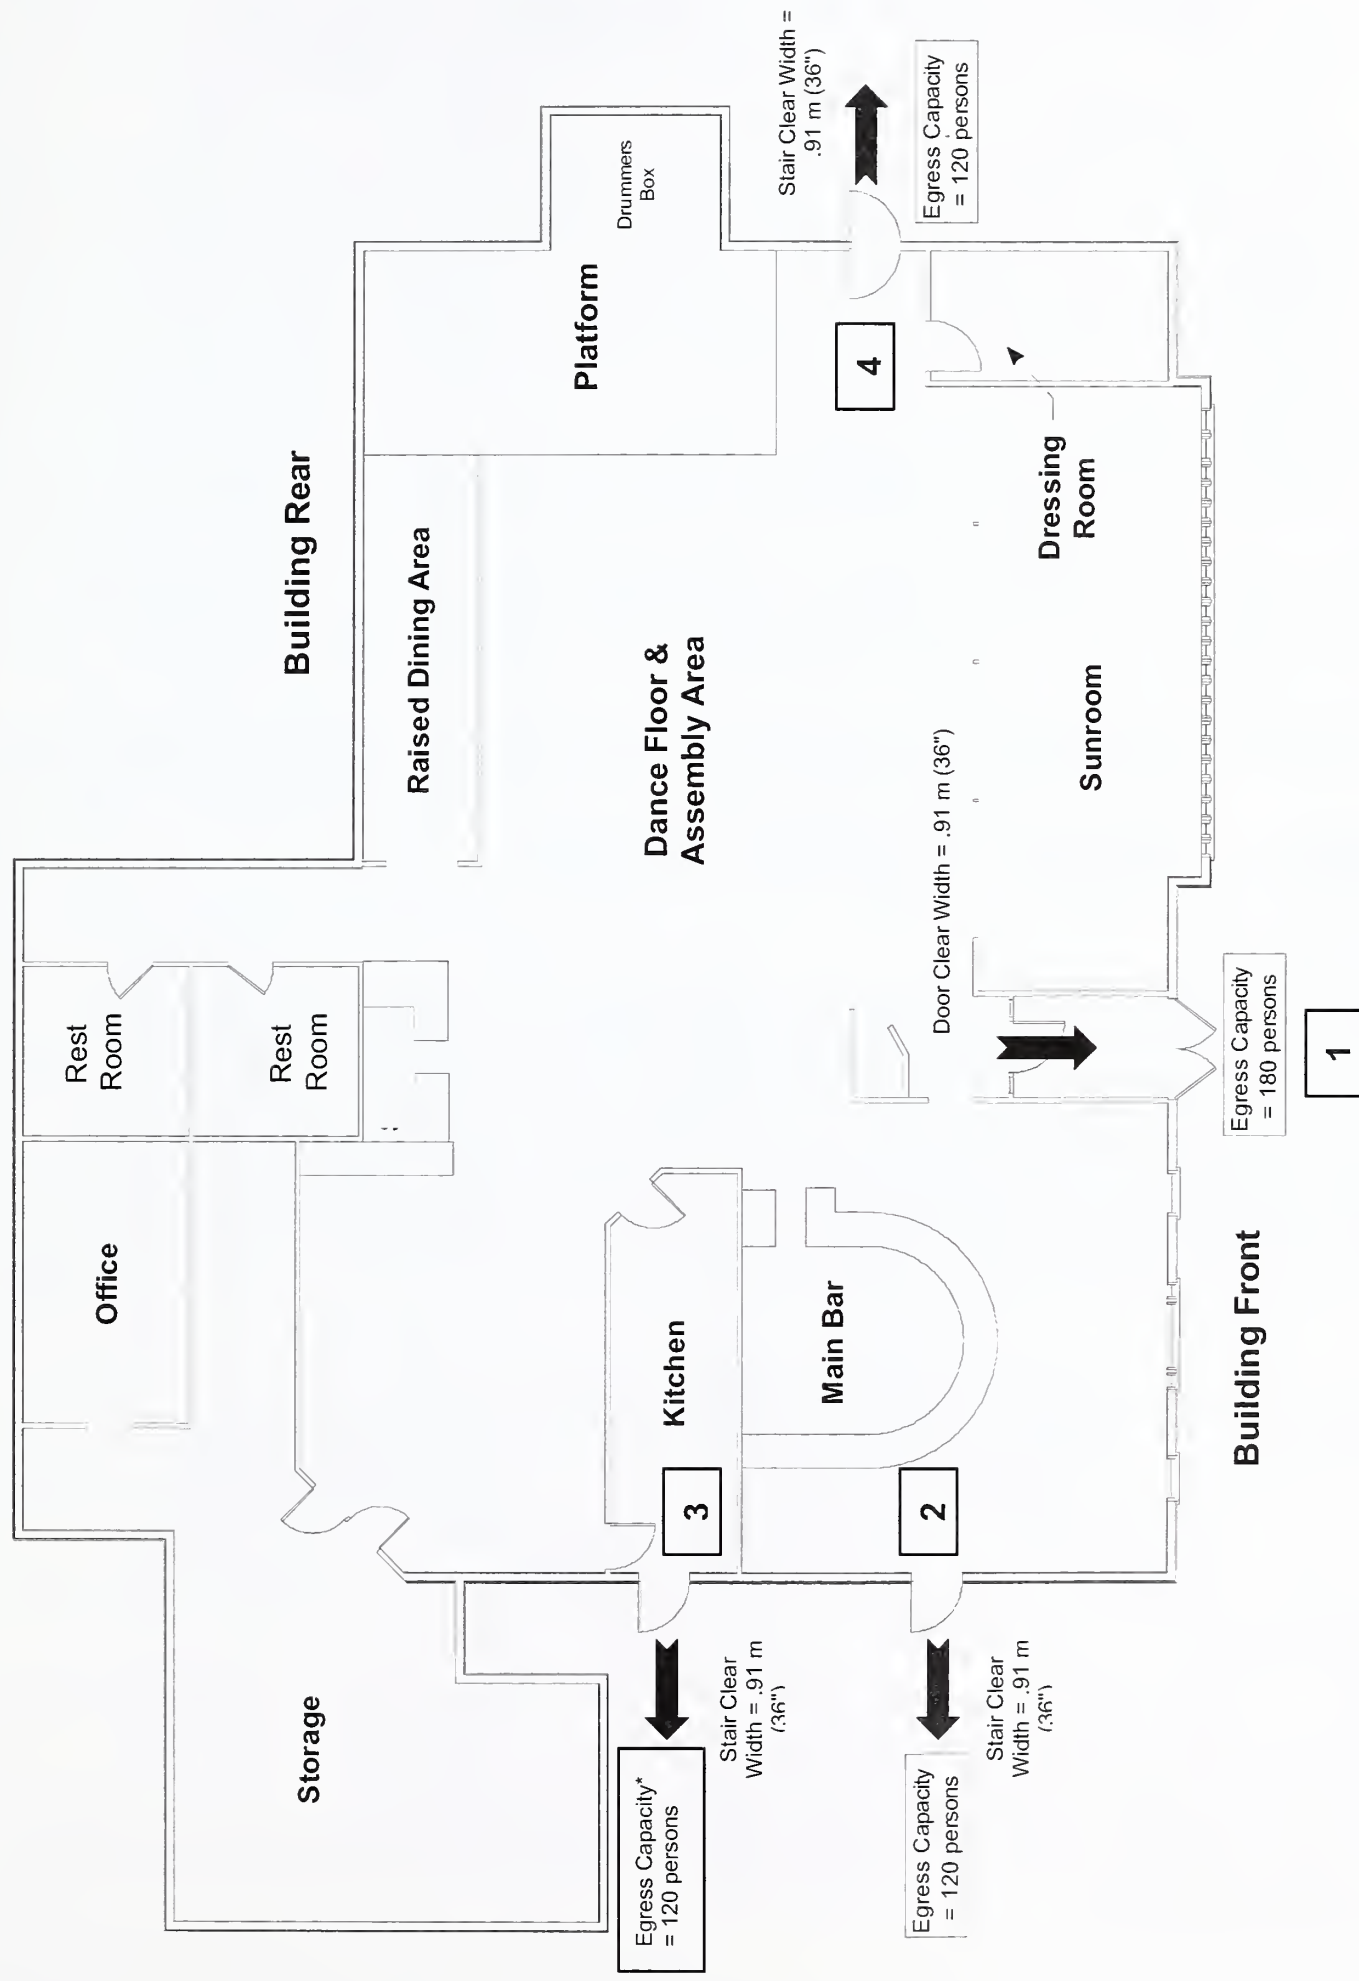
Figure 7-5. Station Nightclub Egress Capacity (*Note that model codes exclude exiting through a kitchen when calculating occupancy limit.)

Comments: All doors exceeded the 0.81 m (32 in) minimum, and all door leaves swung in the direction of egress travel with the exception of the interior leaf at exit 4. (See Fig. 7-5.)

Comments: When viewed from the exterior, the right leaf of the front doors was not equipped with panic hardware. There was no visible hardware on either door. As of this writing, the type of hardware on the swinging door immediately inside the double exterior doors is undetermined. (See Fig. 7-5.)

See Table 7-6 and Figure 7-5 for capacities of each exit. As required by both model codes, the element with the smallest capacity in each path of egress was considered to be the limiting element. The limiting element dictated the capacity of each egress path. For the main entrance, exit 1, the interior 914 mm (36 in) door was the limiting element, resulting in a capacity of 180 persons for the main entrance exit. For exit 2, the side door out of the main bar area, the exterior stairs leading from the door were the limiting element, resulting in a capacity of 120 persons. Exit 3, from the kitchen, was also limited by an exterior stair; however, both codes prohibit egress by patrons through the kitchen (IBC §1013.2 and NFPA 5000 §11.5.2.1) Exit 4 adjacent to the platform had two doors installed on the same jam, one swinging in the direction of egress travel and one swinging opposing the direction of travel. Excluding the kitchen exit and including the exit adjacent to the platform, the occupancy limit based upon egress capacity would have been 420 according to both model codes. (See Table 7-6.)
